DEVELOPMENT OF A PROCEDURE
TO NONDESTRUCTIVELY EVALUATE
THE FUSION QUALITY OF GEOMEMBRANE
SEAMS

RMD Report L-93

Environmental Protection Services
Research Management Division

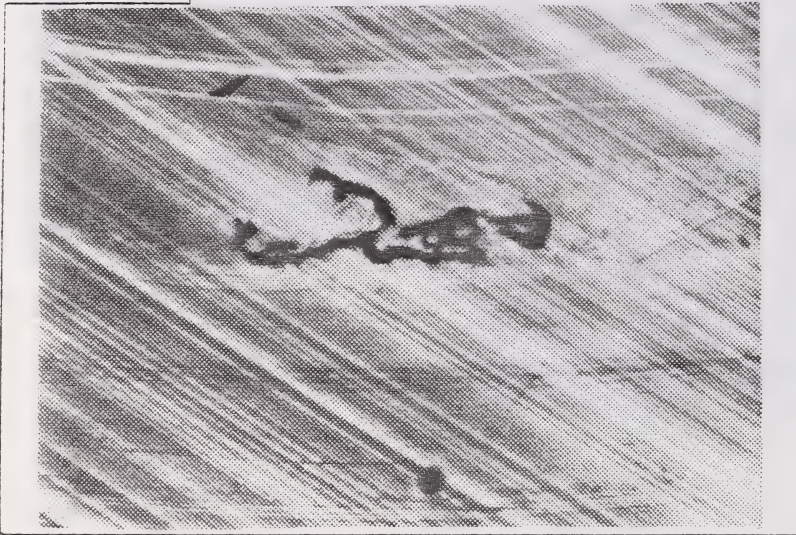
Polarized Light
Mag. X 66.5

Microtome sections revealed dirt or sand particulates on the fusion interface and fibrous material within the extruded material. Lines indicated with arrows are microtome knife markings. The bars show the width of the extruded material in the bottom photograph.

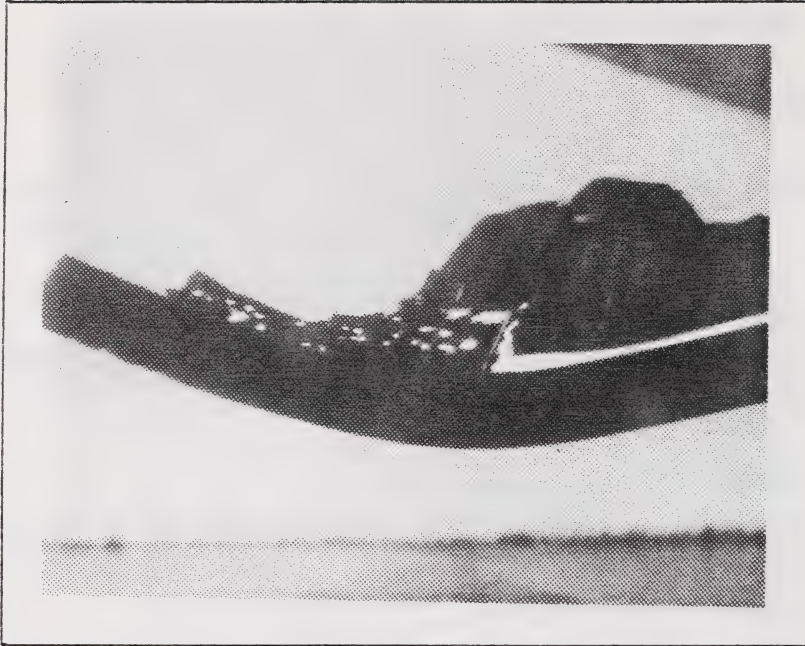
Large amounts of porosity were evident in the areas that showed no ultrasonic signal.

Sample 10. Porosity that causes complete loss of ultrasonic signal.
